A new day dawns for Hubble

Shuttle astronauts installed two new instruments, fixed two older ones, and upgraded the space telescope's gyroscopes and batteries. by Richard Talcott

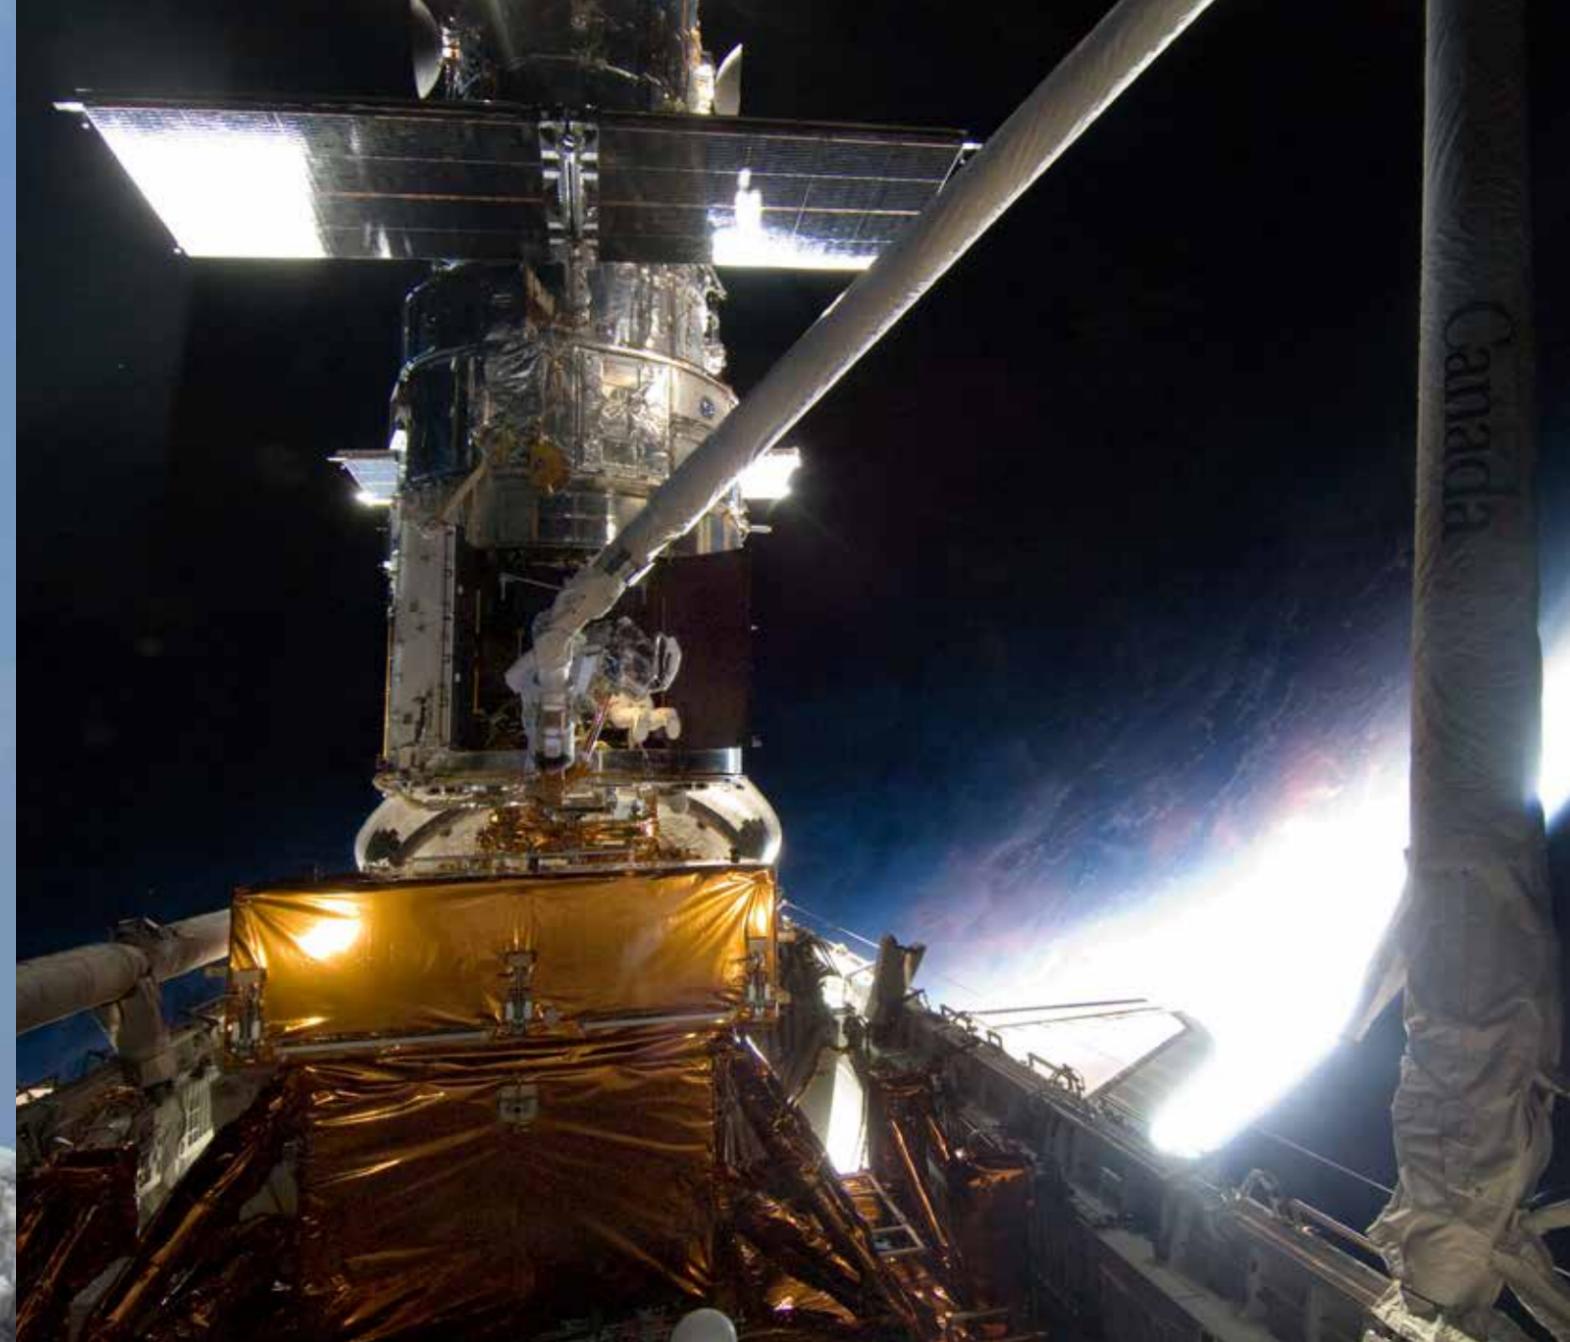
▲ Repairing the Space Telescope Imaging Spectrograph (STIS) occupied nearly all of the fourth spacewalk, in part because of a balky handrail. Here, Michael Good (on the shuttle's robotic arm) and Michael Massimino (just to his right) work on STIS inside Hubble. All images by NASA

The most complex repair took place on the fourth spacewalk when Massimino and Good fixed STIS. NASA did not design the spectrograph for repair. The task required the astronauts to painstakingly remove 111 screws after affixing a "capture plate" over the instrument's access panel to prevent any screws from floating free. Oddly enough, this part of the repair went smoothly, but the astronauts had trouble removing a handrail to attach the capture plate. In the end, Massimino simply yanked the handrail off.

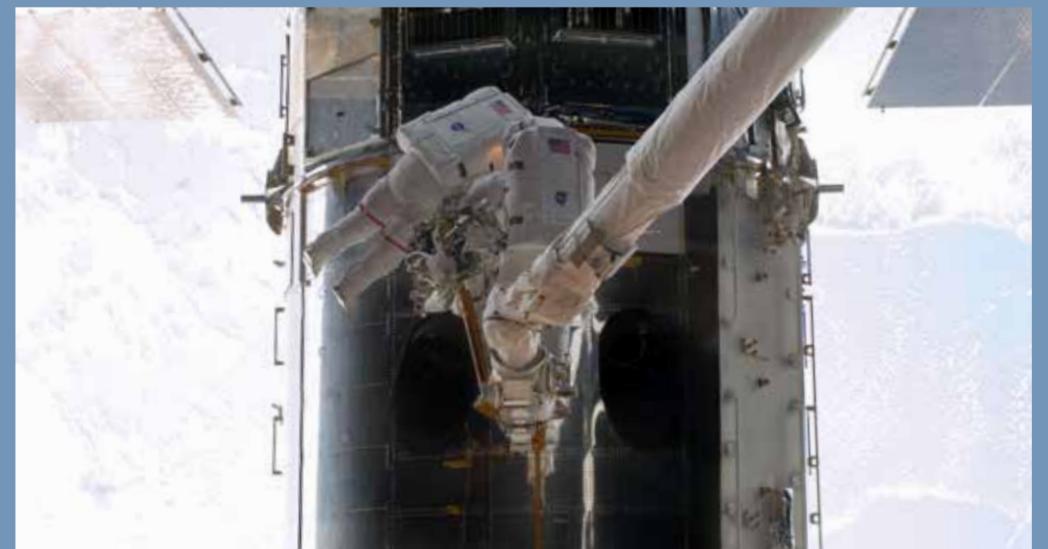
> Wide Field Camera 3 finds its new home inside Hubble, as astronauts John Grunsfeld (left) and Andrew Feustel wrap up the camera's installation during the first spacewalk.

One problem came during the first spacewalk and threatened the installation of what will become Hubble's primary camera. To install the Wide Field Camera 3 (WFC3), Grunsfeld and Feustel first had to remove the Wide Field and Planetary Camera 2 (WFPC2). After more

The astronauts had a difficult time removing a bolt that held the camera in place. They tried a variety of tools and even applied extra force to the bolt, all to no avail. If the bolt had broken, they wouldn't have been able to remove the old camera and install the new one. The pair eventually retrieved a ratchet tool, reconfigured it, and managed to remove the bolt. The rest of the removal and WFC3's installation went perfectly.

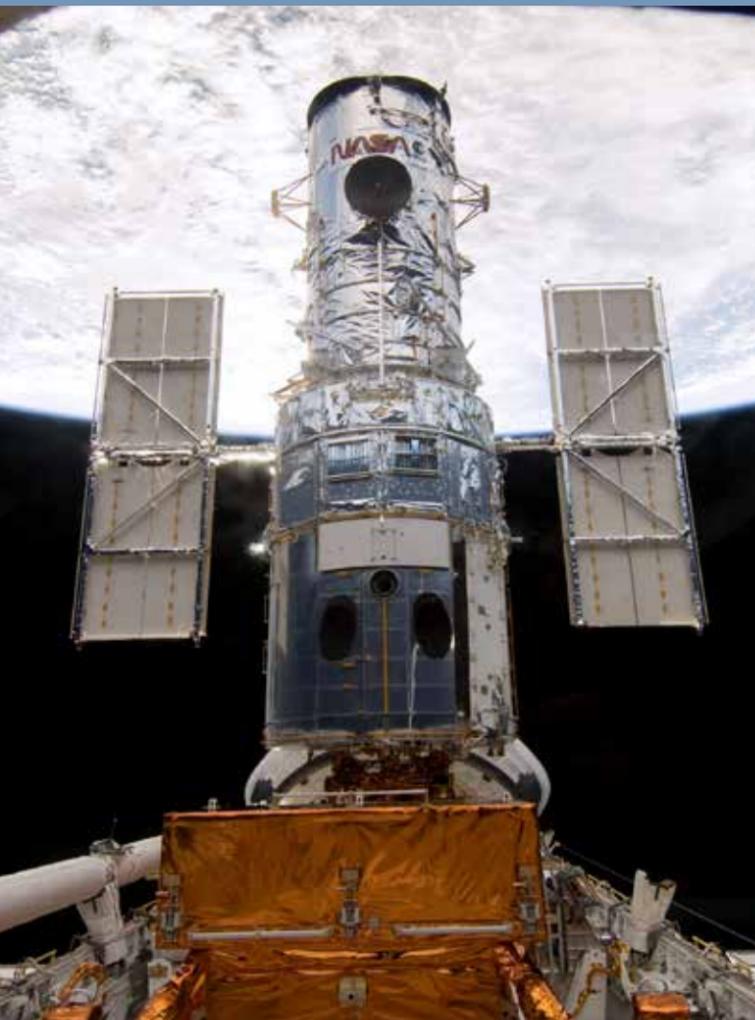
Hubble stands tall in the cargo bay of Atlantis. The crew captured this scene after Mission Specialist Megan McArthur grabbed the telescope with the shuttle's robotic arm.

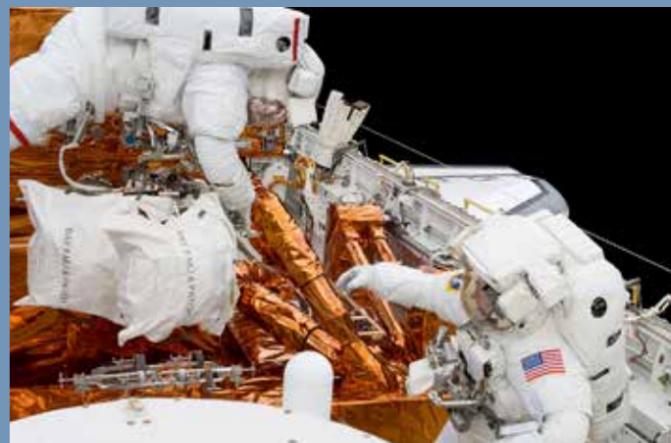
The fifth spacewalk included several maintenance tasks. In this scene, John Grunsfeld (left) and Andrew Feustel prepare to install new thermal blankets on the space telescope.

The other key upgrades went well. Hubble now sports a new Science Instrument Command and Data Handling unit, a new Fine Guidance Sensor, two new batteries, and three new thermal blankets.

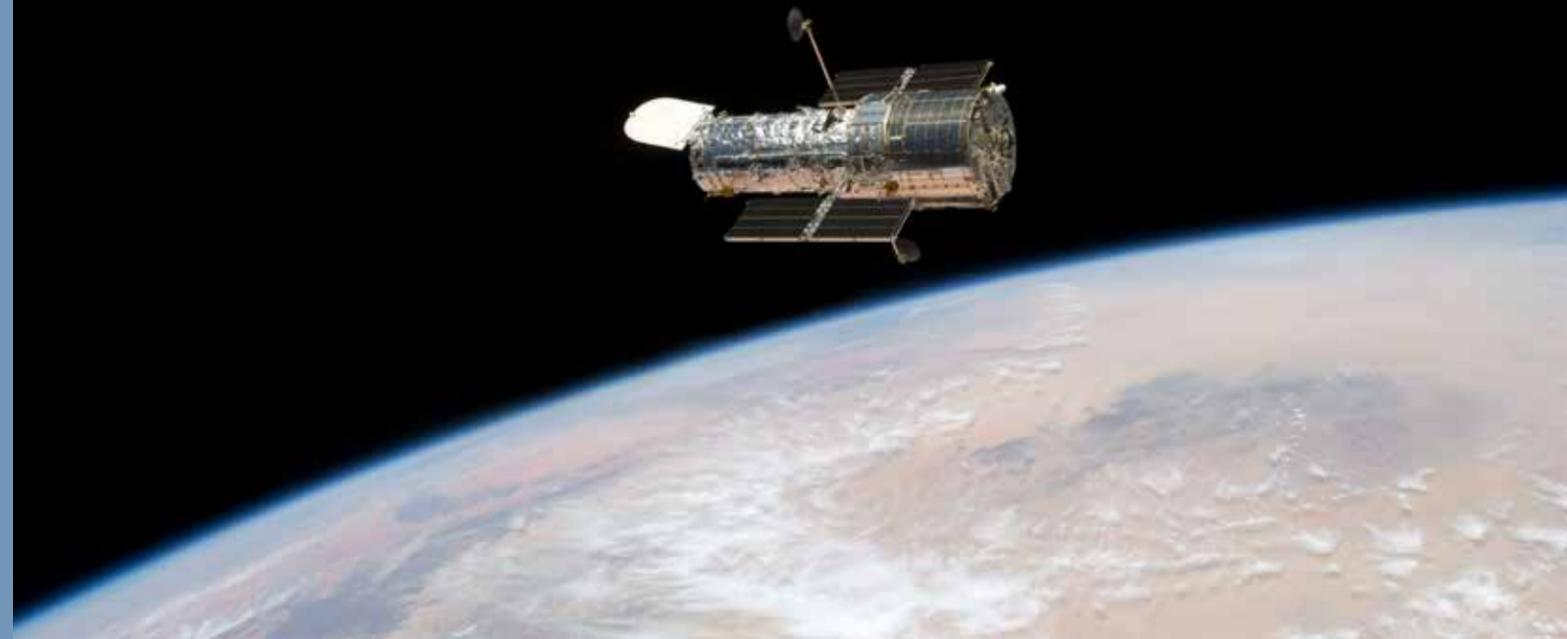
Hubble drifts away after Atlantis' crew finished servicing it. The space telescope should be set for at least 5 more years of discoveries.
